# REFERENCE 72

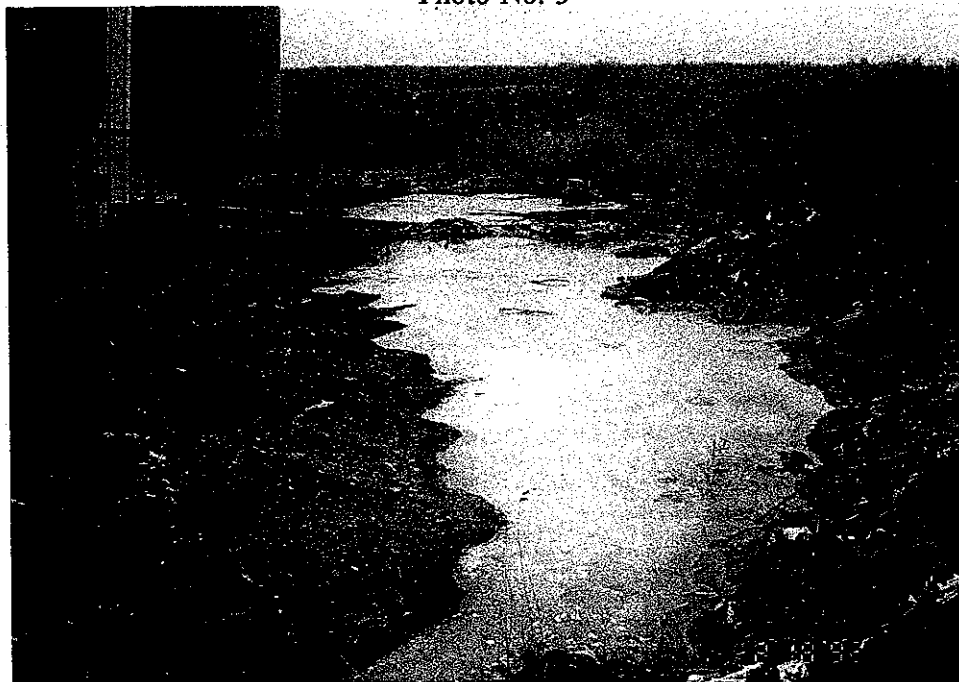
**Photo No. 3**

**Photographer: Jack Brunner Date: 02/18/92 Time: 10:45 a.m. Direction: South**  
**Description: Pond water south and west of the American Add Mixtures building; gas seen bubbling up in this water**

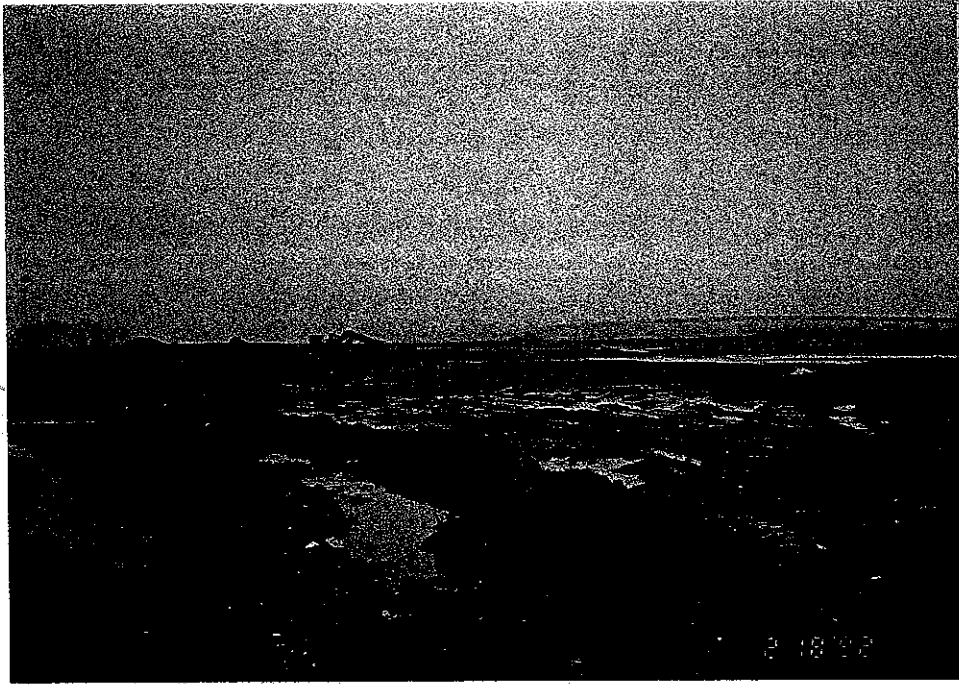
**Photo No. 7**

**Photographer: Jack Brunner   Date: 02/18/92   Time: 11:15 a.m.   Direction: East**  
**Description: Capped area of landfill; clay spreading equipment in background**
